### FIELD SAFETY NOTICES

### MAQUET CARDOIVASCULAR INFORMATION

MCV/2011-06-10/01

MCV/2011-06-10/02

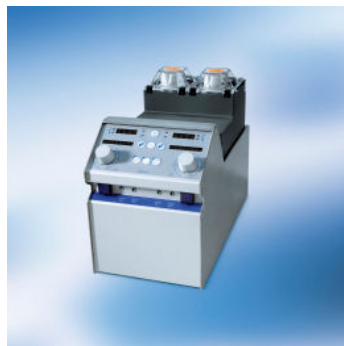
Based on observations in the field and during laboratory testing it has been determined that in very rare cases, it is possible for a HL 20 Twin Pump Module (TPM) (see Picture 1) to unintentionally increase its speed for a 1½ - 2 second period before returning to its originally set speed.

Picture 1: HL20 Twin Pump Module

The root cause of this potential problem is a software bug in version 2.4 or lower which is running on the EPROMS located on the TPM control boards.

Until the software update is performed we advise that you to keep the patient side of the cardioplegia delivery line clamped at all times between cardioplegia deliveries and that you switch off, i.e. power off, the slave pump between between cardioplegia deliveries if you are using the HL20 TPM in cardioplegia master/slave mode.

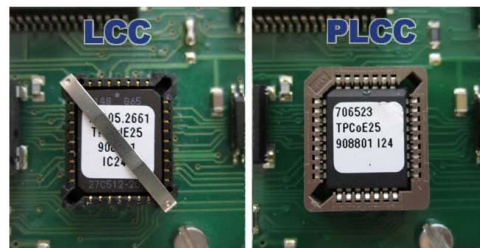
Figure 2: EPROMS on the Control Boards

New software will be installed by exchanging the old EPROMS on the TPM control boards with new EPROMS containing software Version 2.5. (Figure 2)

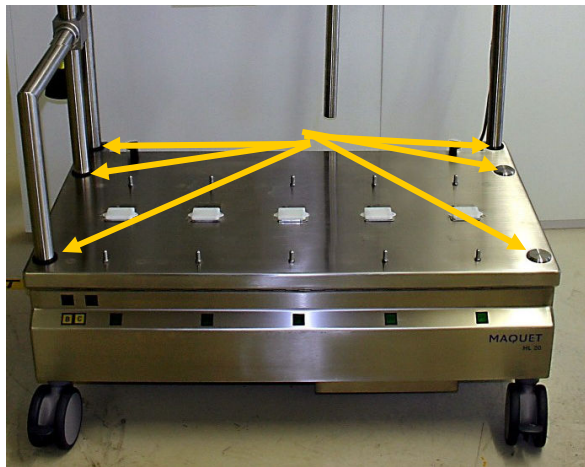
In very rare cases, during cleaning or disinfecting, it is possible for liquids to enter into the HL 20 – 4 pump console or HL 20 – 5 pump console. If an excessive amount of liquid is used, the liquid can accumulate inside the HL 20 console and drip onto the HL 20 power supply board where it might cause the power supply board to malfunction.

The root cause for this potential problem is, that the tolerances of the HL 20 mast diameter, the holes where the masts enter the HL 20 console (Figure 3: arrows show where the liquids can enter the HL20 Console), and the sealing rings may combine in such a way that the overall sealing effect is no longer effective in preventing liquids from entering the machine. This effect may be further compounded by additionally flushing the HL 20 System with excessive water.

Figure 3: HL20 – 4 Pump Console (Example – identical for HL20 – 5 Pump console)  
The arrows show where the liquid can enter the HL20 Console

Please ensure that until the update is performed, no excessive amount of liquid is applied to your HL 20 during normal use and in particular during cleaning and disinfection. Please also refer to the HL 20 User's Manual, Section "Cleaning and Disinfection". This section instructs users not to flush the HL 20 system with excessive water, as this could damage the electronics. The User's Manual also provides information on the chemical solvents (such as alcohol, ether and acetone) which should not be used and that anesthetics (such as Foram (Isofluoran)) should not be spilled over the HL 20 system as these can damage the machine.
